# Geotechnical assessment of ground conditions around a tilted building in Cairo–Egypt using geophysical approaches

**Abstract** The flood plain of the Nile River has been a safe dwelling throughout history. Recently with a growing population and vast growing urbanization some buildings have started to experience structural damages, which are not related to their construction design, but rather to the ground conditions around the buildings' foundations. Variations in properties of the soil supporting the buildings' foundations such as soil bearing capacity, moisture content and scouring may eventually lead to the failure of these buildings. This study is attempting to characterize the variations in the soil properties around the City Star shopping mall, in eastern Cairo, where a large building has tilted over the past few years. This tilting may lead to the collapse of the whole building if it continues at the same rate. An integrated geophysical investigation including multi-channel analysis of surface wave (MASW), ground penetrating radar (GPR) and 2-D electrical resistivity tomography (ERT) was used around the affected building to help detect possible causes of deterioration. T

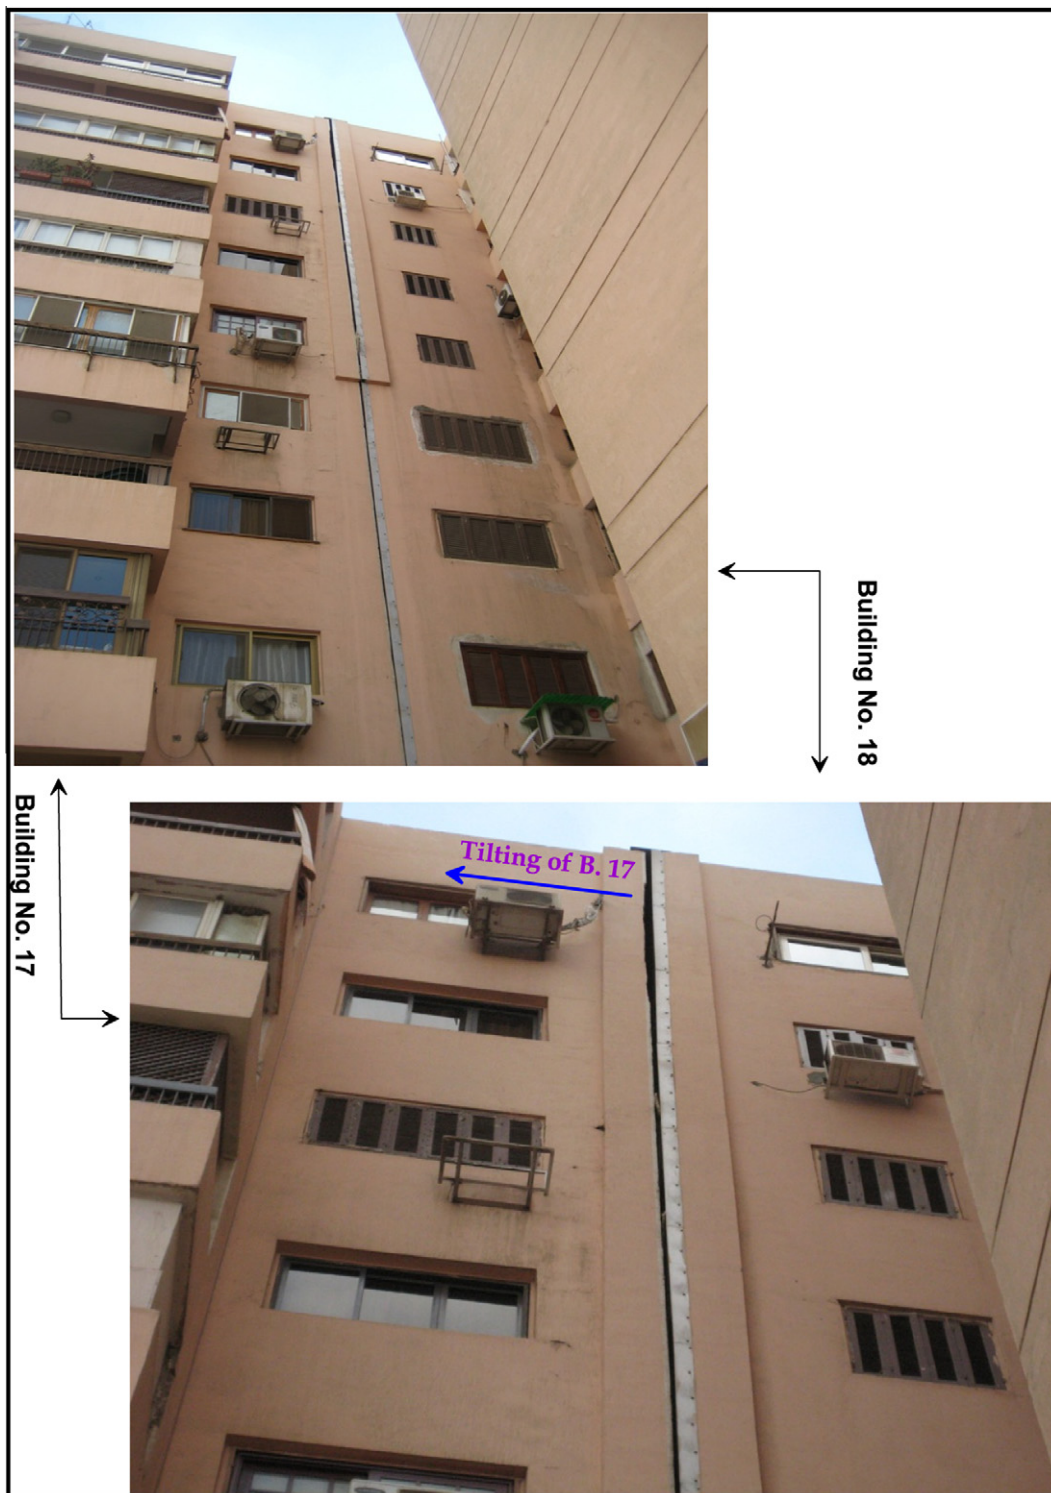
**Figure 3** Tilting of Building No. 17 relative to Building No. 18.

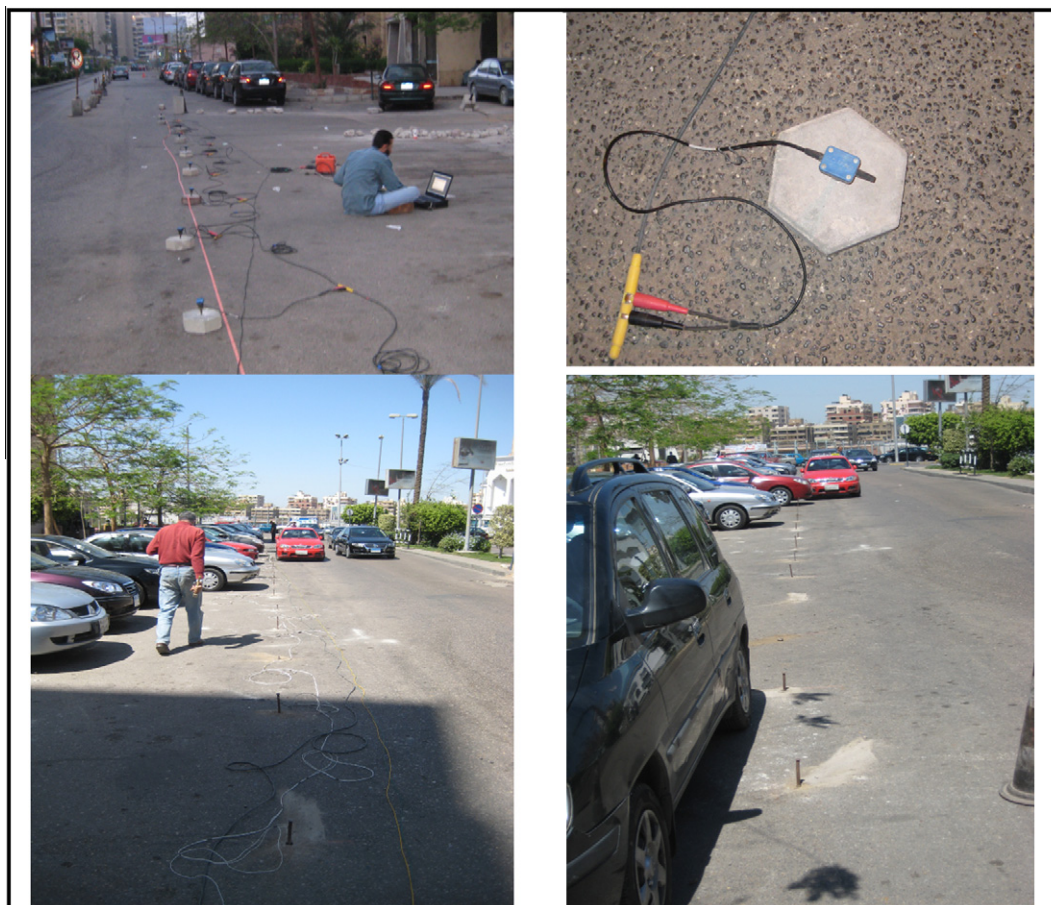
**Figure 5** Acquisition processes of the MASW data using geophones attached to concrete plates and the ERT data where long steel electrodes were used to penetrate the asphalt down to the conductive soil layer underneath the asphalt.

by soft clay (Fig. 5). The acquired data were not of high quality due to the location of the surveyed site in the center of the heavily populated area. Cultural noise from traffics, pedestrians, power lines and other sources generated noise in the recorded shot gathers.

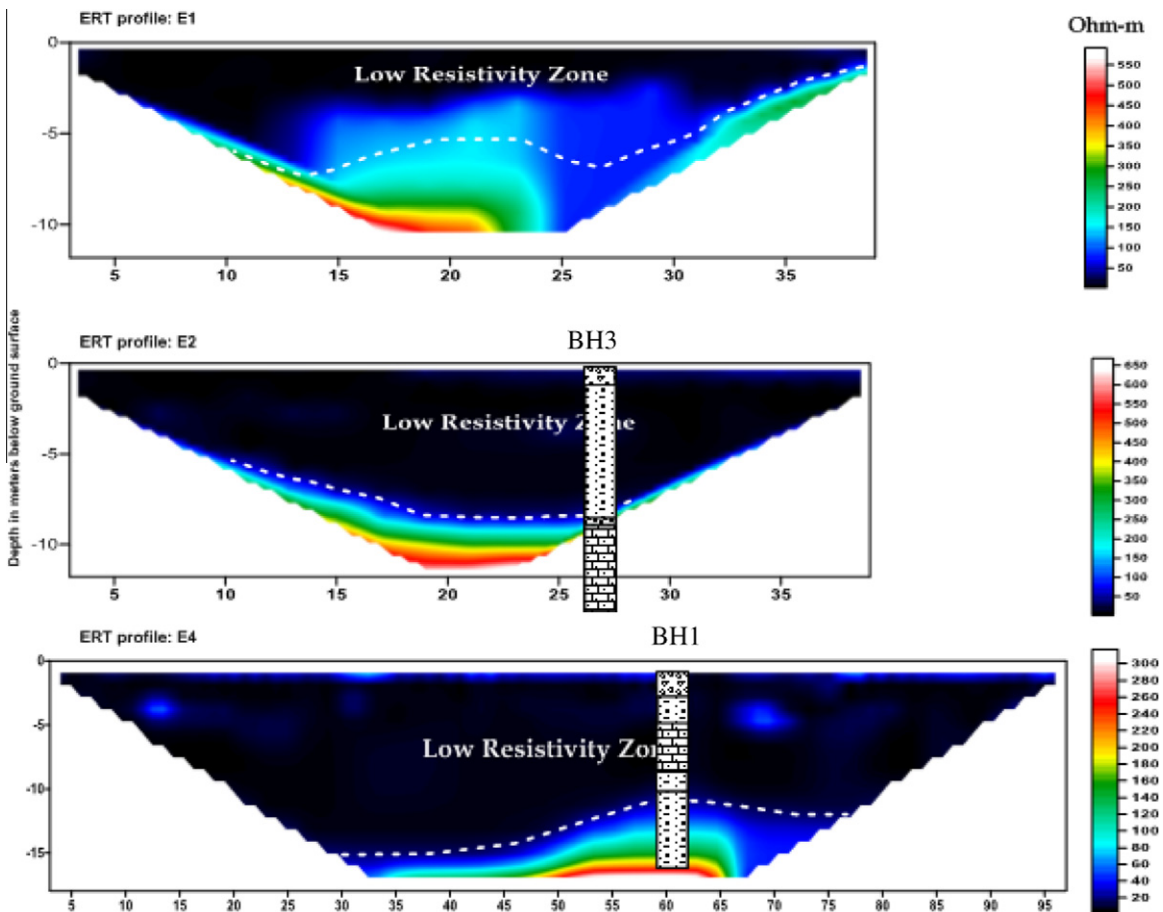
Generally the ERT profiles (Fig. 13) show two distinct layers. The upper layer starts from the ground surface and extends down to a depth of 3–10 m. This layer is characterized by rel-

atively low resistivity which most likely corresponds to a higher clay- or moisture content soil. The lower layer is characterized by relatively high resistivity which reflects the presence of clay soil which varies in its lateral and vertical extents. The thickness of the low resistivity zone has the lowest value at profile E1 to the west of the building. Profile E2 (south of the building) shows low resistivity zone thickness that change from 5 to 10 m. The other two profiles #4 and #5 (north and east of the building, respectively) show the maximum occurrence of low resistivity zone with a thickness of 10–15 m. This result indicates that the foundation of the building has been rooted in the low resistivity zone corresponding to heterogeneous sediments (clay with intercalations of sand and gravel).

Figure 13 Three representative ERT profiles E1, E2 and E4 with the interpretation superimposed on the profiles.

conditions. Integrating the interpretation of the MASW and the ERT images with the boring information showed that the dominant soil within the upper 15 m is clay to silty clay with sand intercalations. This is underlain by sandstone intercalated by clays or silt to a depth of 25 m. The thickness of the upper layer from the ERT and MASW sections varies from line to line as described above. In addition to variations in thickness, variations in resistivity and shear wave velocity within the upper layer indicate that the subsurface soil is heterogeneous and varied in its rigidity (bearing capacity) and its compaction. Based on the rigidity retrieved from the MASW, the bearing capacity is not uniform in the area of the building.
